Coastal Erosion from Space

Waterline Verification and Quality Control

Ref:SO-TR-ARG-003-055-PVR-A2

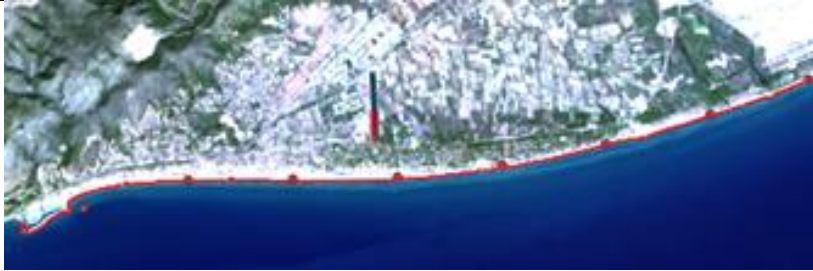
Waterline extraction using Landsat 8 L1 data (20130705)

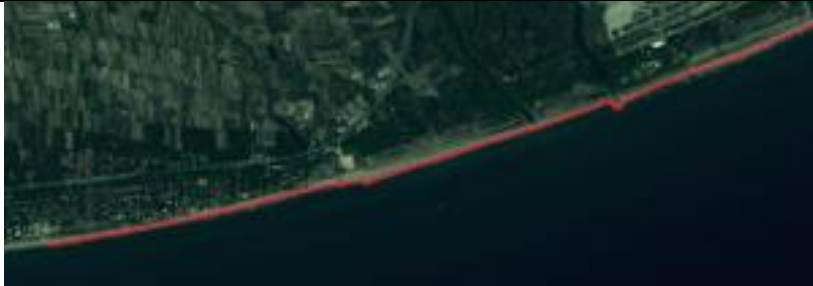
Success
Waterline extraction using WorldView2 data (20171017)

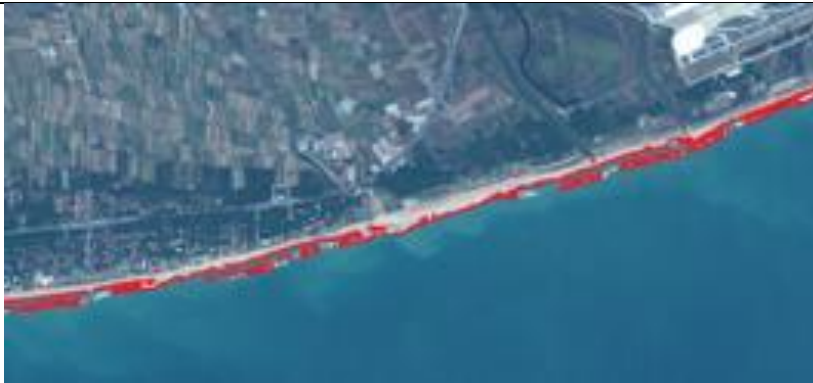
Success
Waterline extraction using GeoEye data (20110202)

Success, although in this instance white caps on waves are picked up erroneously as edges
Waterline extraction using Ikonos data (20090521)

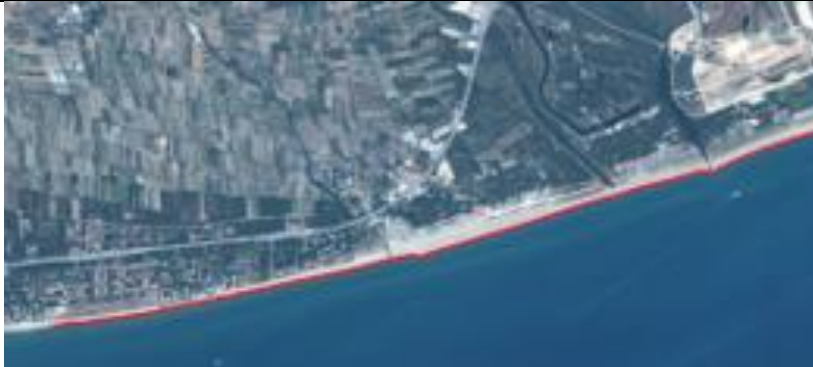
Success
Waterline extraction using QuickBird data (20040530)

This test at the Barcelona site provided crucial verification that the processor works with a variety of image types. There are plans to expand these capabilities to cover images from the satellite Rapid Eye during the latter stages of Phase 2.

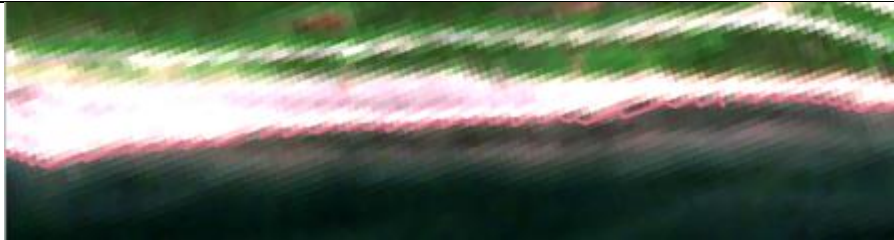
Worked reasonably well for S2 image of 01/07/2019

As this test displayed, the optical waterline extraction method is constrained by issues related to suspended sediments. Turbid waters create discontinuities and can confuse the algorithm in identifying the correct boundary between the wet sand and the turbid water. A fifth test elaborated further on this question, by looking at the dynamically changing Wexford Estuary and its immediate

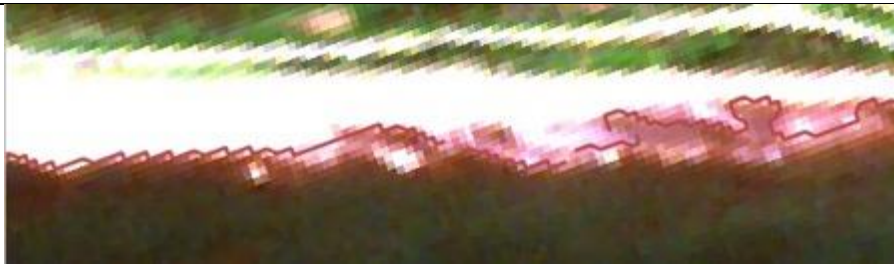
Success
Discontinuities for S2 image of 01/07/2019

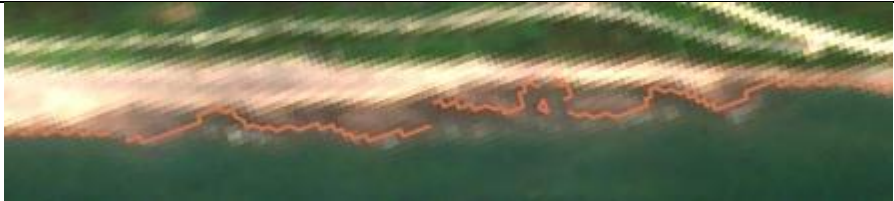
Failure
Discontinuities for S2 image of 26/07/2019

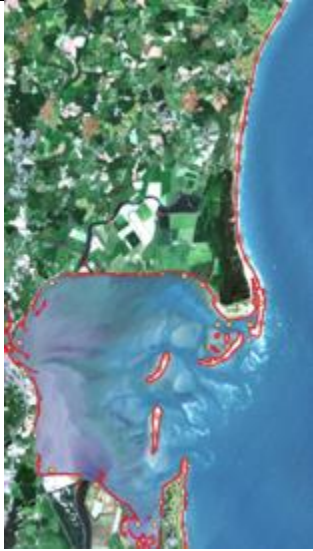
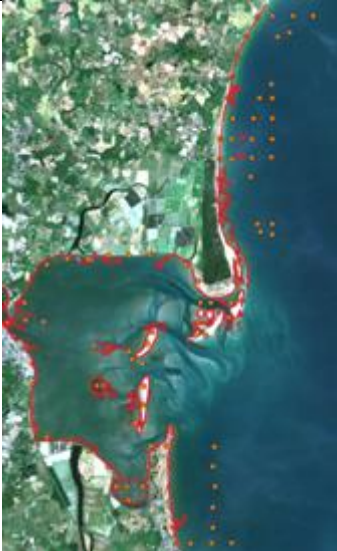
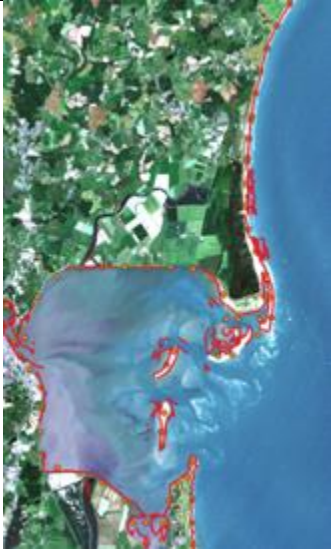
Table 1.5: Test 5 – Test of the waterline processor’s ability to produce continuous waterlines in a complex estuary

Success	Failure	
<p>More or less good results, with the sand banks being picked up approximately correctly, as well as the shoreline north of the estuary. The inner estuary remains problematic due to suspended sediments. GNDVI-based Sentinel 2 waterline from 27/06/2019 (LW +4.5hrs)</p>	<p>Shifting sands, suspended sediments & nearshore bathymetry causing false edges</p> <p>Sentinel-2 tiles: NDVI-based waterlines from 22/06/2018 LW +4.5hrs (LHS) and from 27/06/2019 LW +4.5hrs (RHS)</p>

Estuarine environments have proven to be challenging for the optical waterline approach, however results have been largely improved by testing the algorithm with different band ratios and adjusting the thresholding for the land-water delineation.

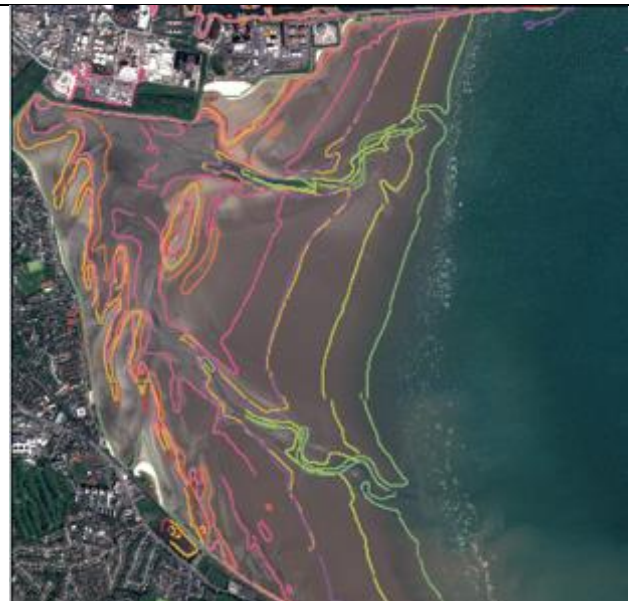
Table 1.6: Test 6 – Verification that the processor can produce continuous waterlines for images of intertidal areas at low levels of tide, with S2 waterlines based on images recorded in the period 08/12/2015-27/02/2020 at different levels of tide

The 10 S2 waterlines are based on images representing different levels of tide between 08/12/2015-27/02/2020. The background is a 0.5m resolution Worldview-2 image from 06/22/2014.

As the above test shows, the waterline processor recognizes intertidal features such as sandbanks and puddles at low levels of tide, and also delineates the sea-land interface.

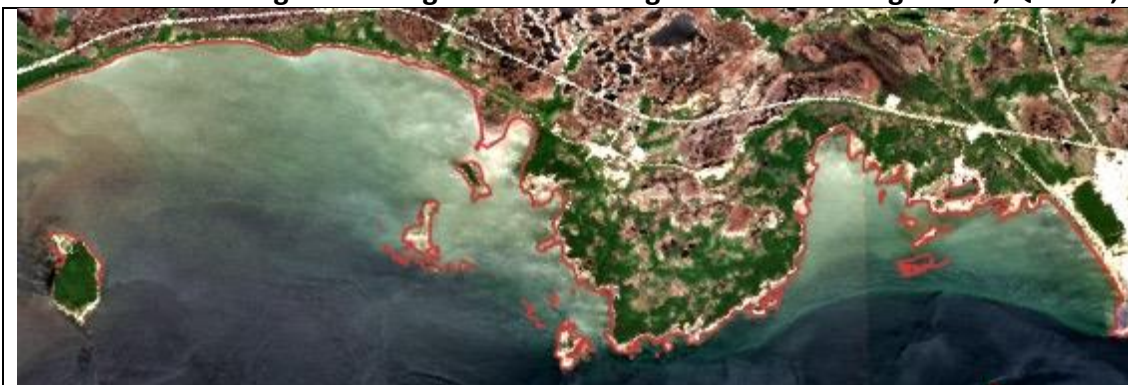
Table 1.7: Test 7 – Verification of the waterline processor’s ability to produce continuous waterlines with sun-glinted images from the Longue Pointe de Mingan AOI, Quebec, Canada

Continuous waterline segment at land-water interface from S2 image from 11/06/2019

As the above test showed, it was not sun glint that posed problems for the waterline processor. In the above two images, it worked relatively well and produced continuous waterlines. However, some false edges could also be observed on those images, as the processor picked up offshore features due to sediments and/or pronounced underwater morphology. The below two snapshots are from the same respective S2 images and show serious discontinuities in the waterlines. The different colours of water that can be observed in these images allude to the origin of the discontinuities and the false edges: turbid waters and nearshore bathymetry. Therefore, it can be concluded that sun glint, does not pose a hindrance for the correct functioning of the waterline processor.

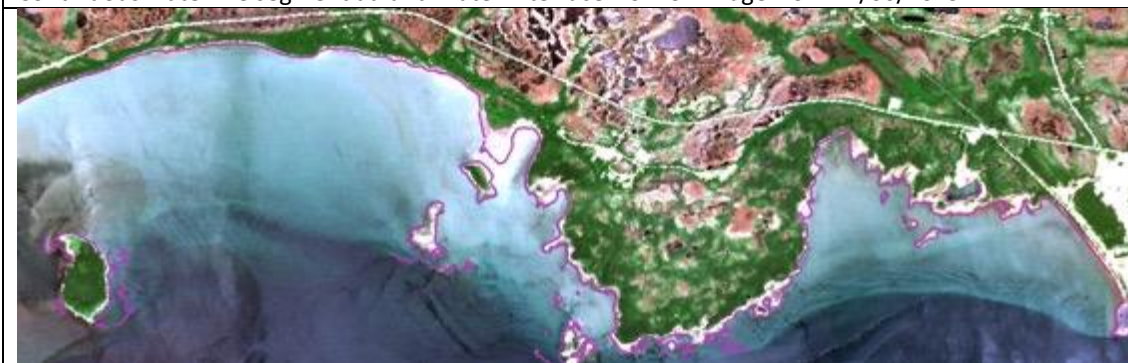
Continuous waterline segment at land-water interface from S2 image from 11/07/2019

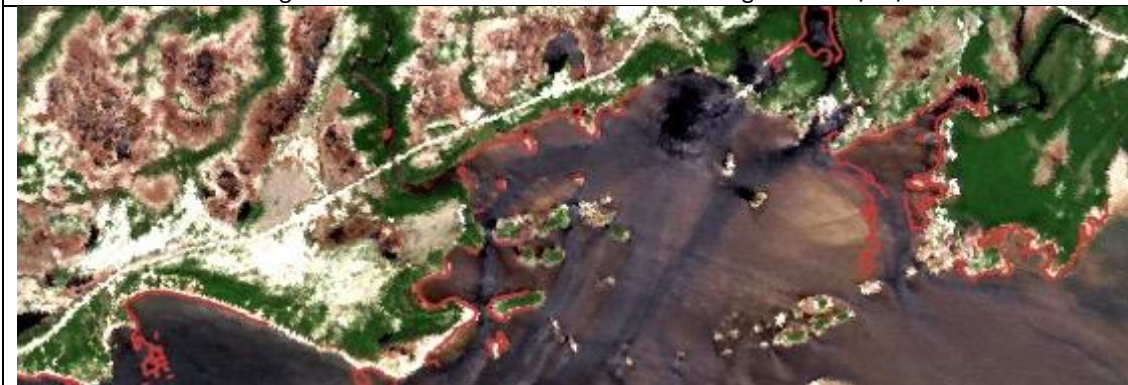
Discontinuous waterline segment from at land-water interface S2 image from 11/06/2019

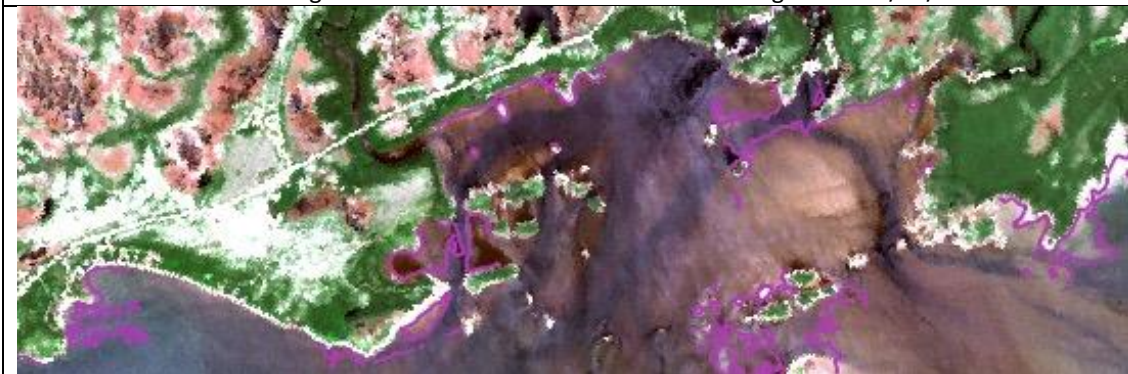
Discontinuous waterline segment at land-water interface from S2 image from 11/07/2019

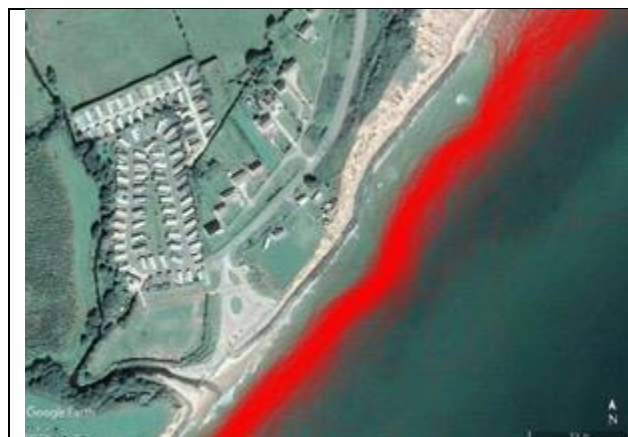
Case 3 – Beach and dunes/hills nearby

Ascending passes: The slope of the dunes is shadowing the shore.

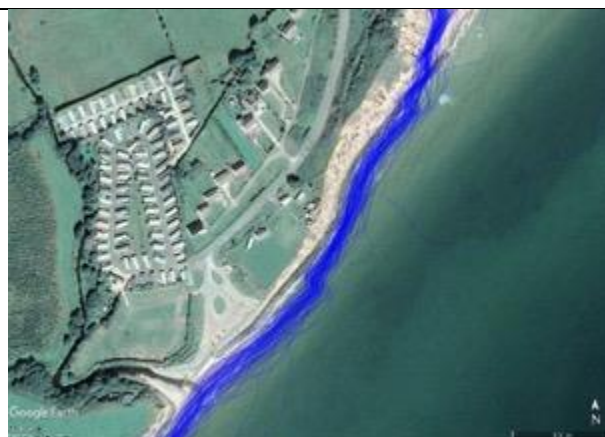
Descending passes

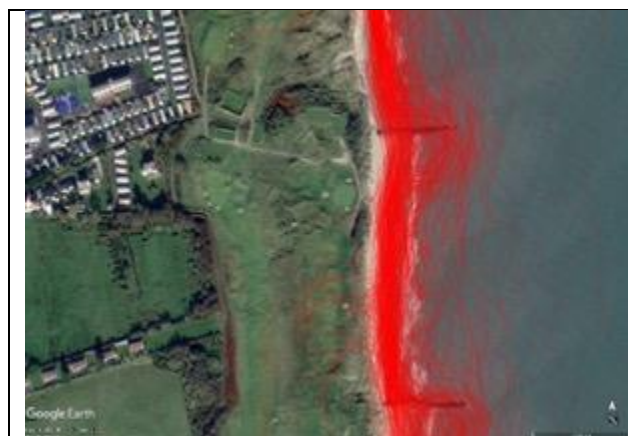
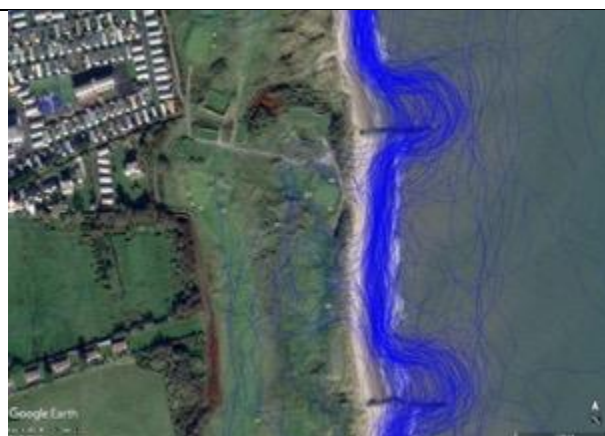
Case 4 – Beach with barriers

Ascending passes:

Descending passes: The barriers create a strong signal shadowing the shoreline interface.

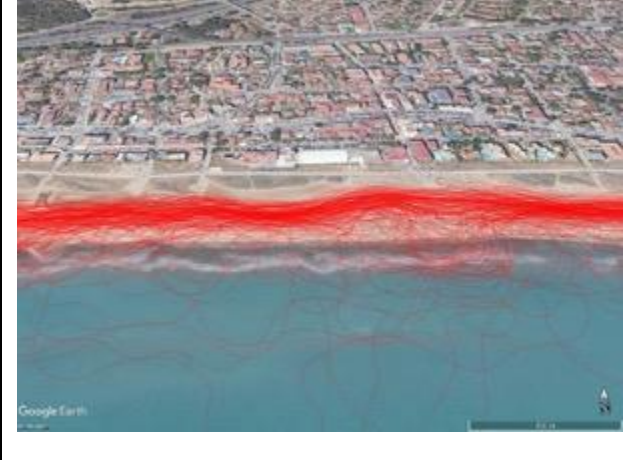
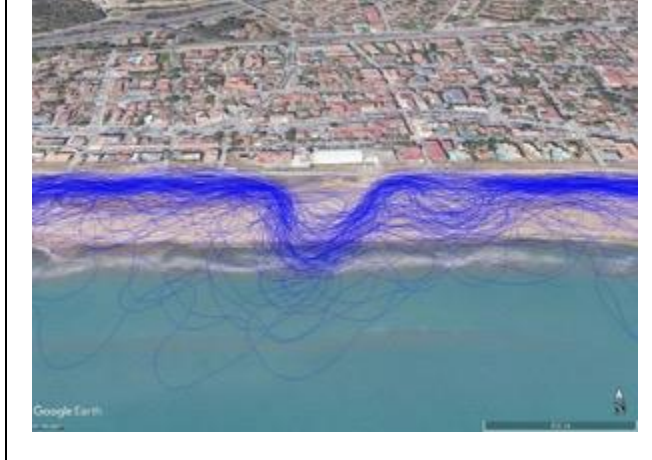
Case 5– Buildings

<p>Ascending passes:</p>	<p>Descending passes: Buildings can create strong signal shadowing the shoreline.</p>

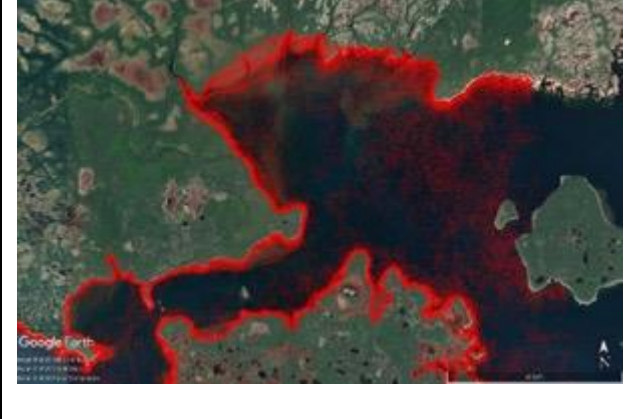
Case 6– Sea Ice (Quebec)

<p>Descending passes not available in Canada.</p>
<p>Ascending passes: Sea Ice dynamics creates lines far from the shoreline.</p>	<p>Descending passes:</p>

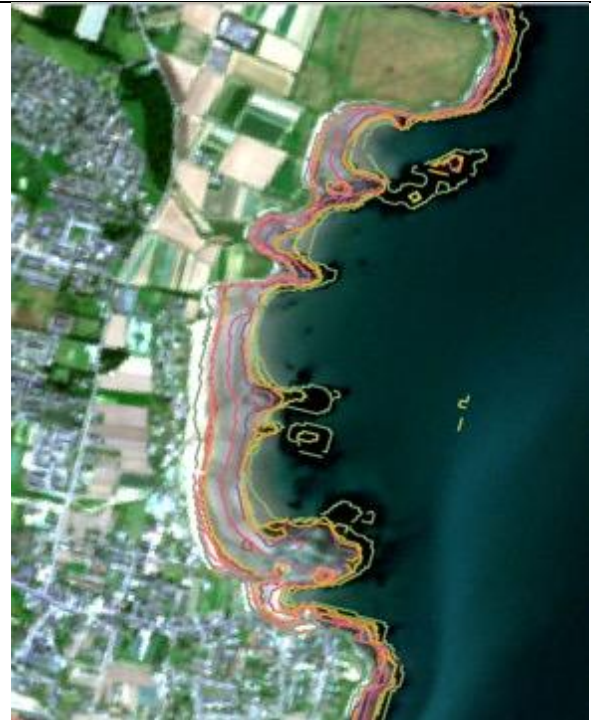
Table 2.1: By eye quality check of GNDVI-based S2 waterlines for the ROI containing Dublin Bay and Rush, underlaid S2 image taken on 17/07/2017

The 1st step of the QC process is to overlay a subset of the produced waterlines on an RGB composite of the ROI and observe them for outliers.

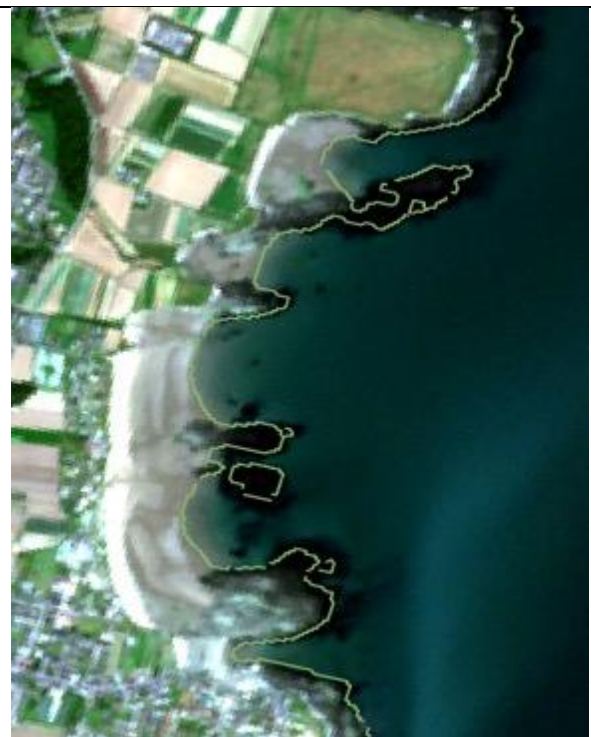
An outlier found:

The waterline corresponding to the underlaid image picks up nearshore underwater features as false edges between water and land. Therefore, this waterline can be considered to be discarded from further analysis.

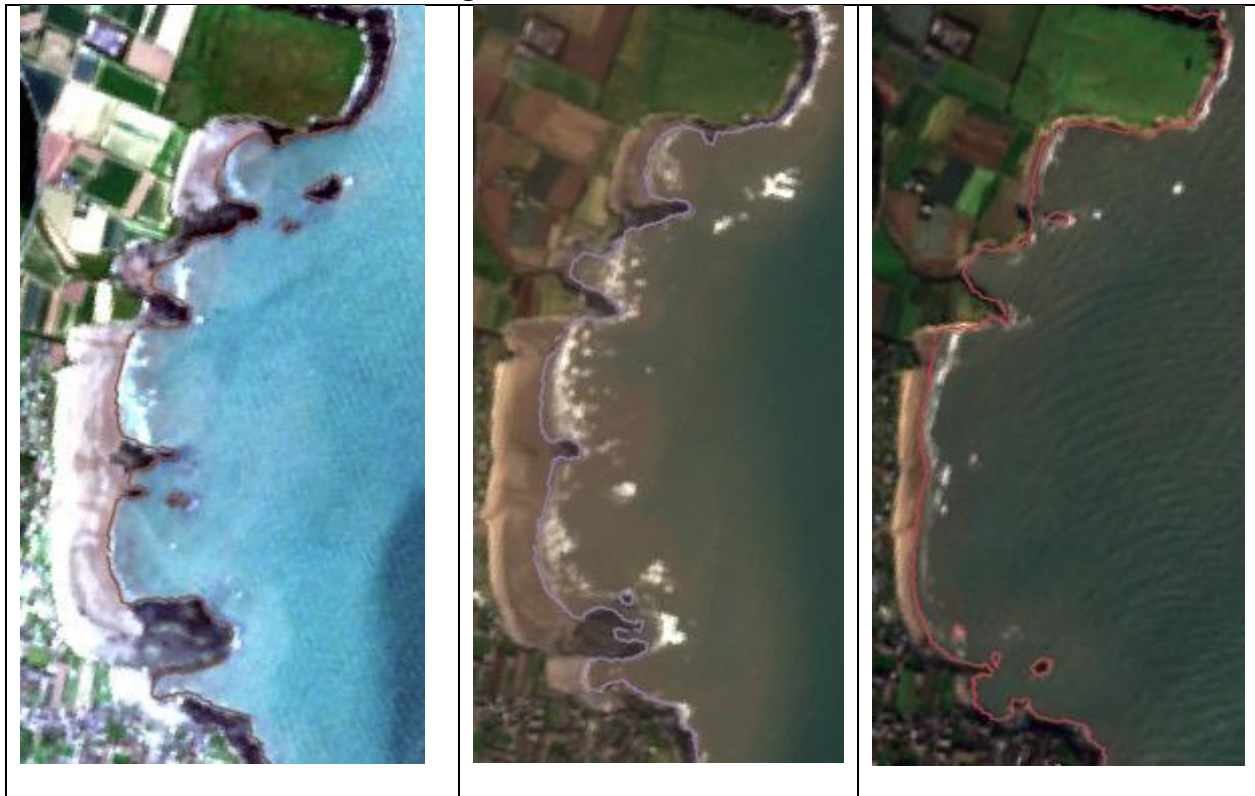
Table 2.2: By eye quality check of GNDVI-based S2 waterlines for the ROI containing Dublin Bay and Rush, LHS underlaid S2 image taken on 17/07/2017, middle underlaid S2 image taken on 14/03/2016, RHS underlaid S2 image taken on 08/12/2015

After discarding the bad quality waterlines from further analysis, the good ones are shared with the partners and are also the base of derived products. Three examples of them that passed the QC process are illustrated in the below table (Table 2.2).

As demonstrated above, the QC process can be reasonably time-consuming. Currently there are steps taken to automate the outlier detection of the QC process and speed up this step.
